## Test Report

Report Number: 150490SHJ-AMQS

Product: Auto Radiator  
 Model: RA-01  
 Samples Quantity: 3 pieces  
 Sample ID: N/A  
 Date Received: Apr. 10<sup>th</sup>, 2015  
 Date Test Conducted: Apr. 13<sup>th</sup>, 2015 – May 6<sup>th</sup>, 2015  
 \*Trademark: N/A  
 \*Rated capacity: N/A  
 \*Size/color: Black frame  
 Test address different from lab address (if existed) : N/A

Test protocol/standard: SASO 82/2008, SASO 83/2008  
 SASO 2278/2011

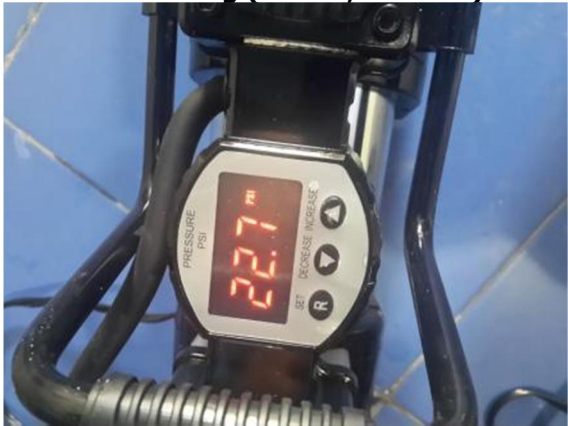
| TESTS PERFORMED | | | | |
|---|---|---|---|---|
| 2 | Leakage Test | <ul style="list-style-type: none"> <li>- The water outlet pipe and the upper and lower tanks shall be tightly sealed and the pressure cap replaced by a normal close fitting cap (without pressure valve).</li> <li>- The inlet water pipe shall be connected to an air supply source at a pressure of 150 kPa (about 1.5 kg/cm<sup>2</sup>).</li> <li>- The radiator shall be immersed in water and subjected to pressure for a period of not less than 30 seconds and any leakage observed.</li> </ul> (SASO 83/2008, section 6 requirements) | Major | Meet |
| <b>OBSERVATION:</b> No leakage was found during test.<br><br><div> <div>Test setup</div> </div> <div> <div>Pressure reading (22 PSI, 150 kPa)</div> </div> | | | | |

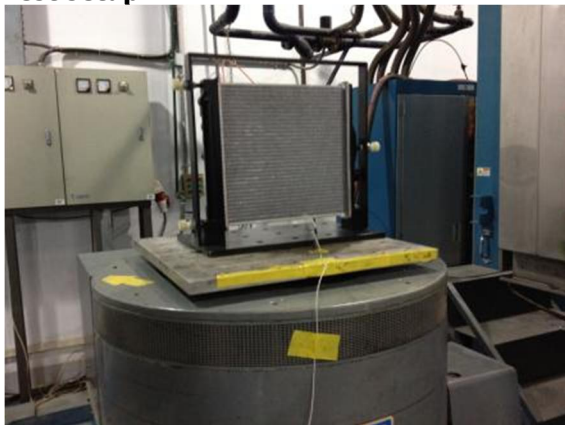
| TESTS PERFORMED | | | | |
|---|---|---|---|---|
| 3 | Corrosion Resistance Test | The radiator shall be exposed from both sides to a (5 ± 1%) (by weight) salt water spray for 4 days and allowed to stand for drying out in a room at a temperature of 23 ± 2oC and 60 ± 10% relative humidity, for 14 days. The radiator shall then be subjected to a hydraulic pressure of 100 kPa (nearly 1.0 kg/cm <sup>2</sup> ) and any leakage observed.<br>(SASO 83/2008, section 5 requirements) | Major | Meet |

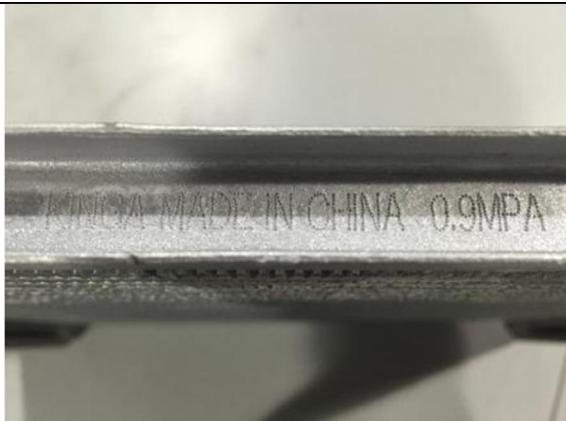
| | | | | | | | | | | | |
| | <b><u>ACTION:</u></b> N/A | | | | | | | | | | | |
| 5 | Labelling | In a prominent place on each radiator the following information shall be legibly and indelibly marked in Arabic or English language.<br>1 Manufacturer's name, and/or his trade-mark.<br>2 Country of origin.<br>3 The pressure at which the cap valve opens.<br>(SASO 82/2008, section 5 requirements) | Major | Meet | | | | | | | | |
| <b><u>OBSERVATION:</u></b><br>Required markings were found on sample. | | | | | | | | | | | | |
|

<table><tr><th>Requirement</th><th>Finding</th></tr><tr><td>Manufacturer's name, and/or his trade-mark</td><td>"KINGA" was marked on sample.</td></tr><tr><td>Country of origin</td><td>"Made in China" was marked on sample.</td></tr><tr><td>The pressure at which the cap valve opens</td><td>"0.9 MPA" was marked on sample.</td></tr></table>
