# 检 测 报 告

项目名称 Project Name: GUANGZHOU KINGA AUTOPARTS  
INDUSTRY MANUFACTURE CO LTD

试验件名称 Test Sample: AUTO RADIATOR RA-01

试验项目名称 Test Item: 腐蚀试验 Corrosion Test

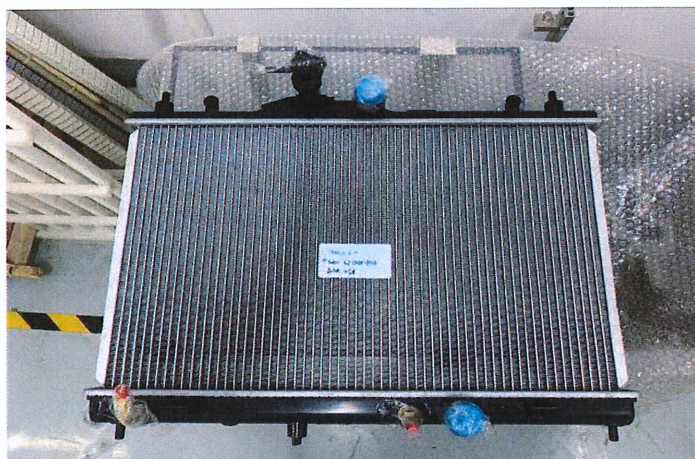
## 1.1 Test sample/试验样品

测试状态

Test State

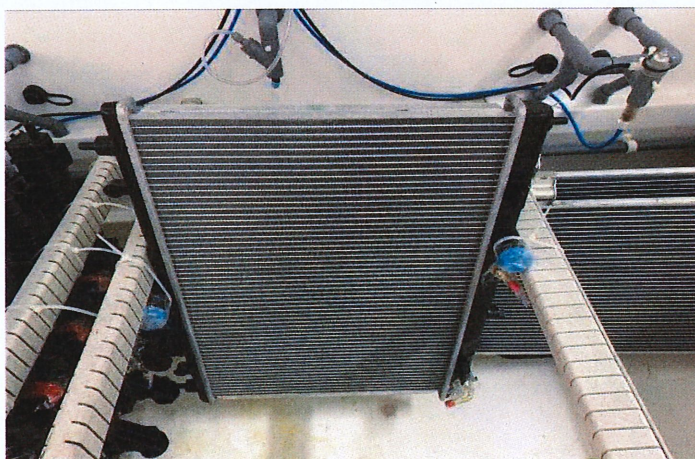
## 1.3 Test setup/试验设置

安装状态

Set-up state

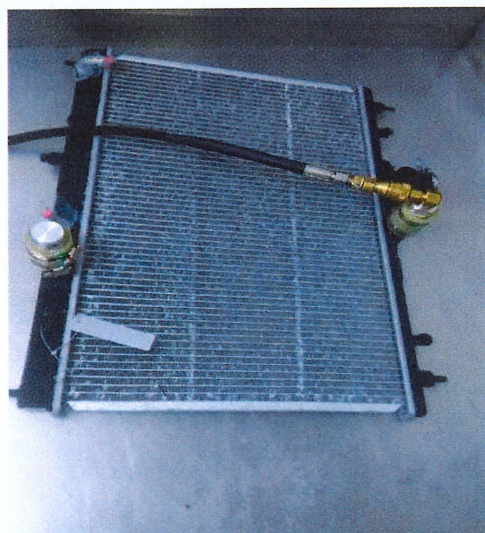
## 2.1 Summary results/实验结果总结

泄露测试  
Leakage test

**Conclusion :** There are no leakage of the test sample, 腐蚀后样件无泄漏

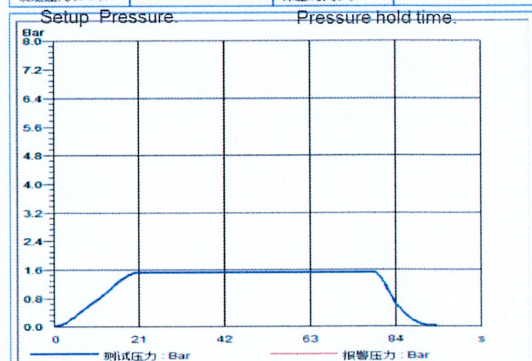
| 设定压力(Bar): | 1.5 | 保压时间(s): | 60 |
